EXPERIMENTAL INVESTIGATION OF RIM CRACKING IN DISKS

SUBJECTED TO HIGH TEMPERATURE GRADIENTS

By P. I. Wilterdink

WASHINGTON
September 1, 1949

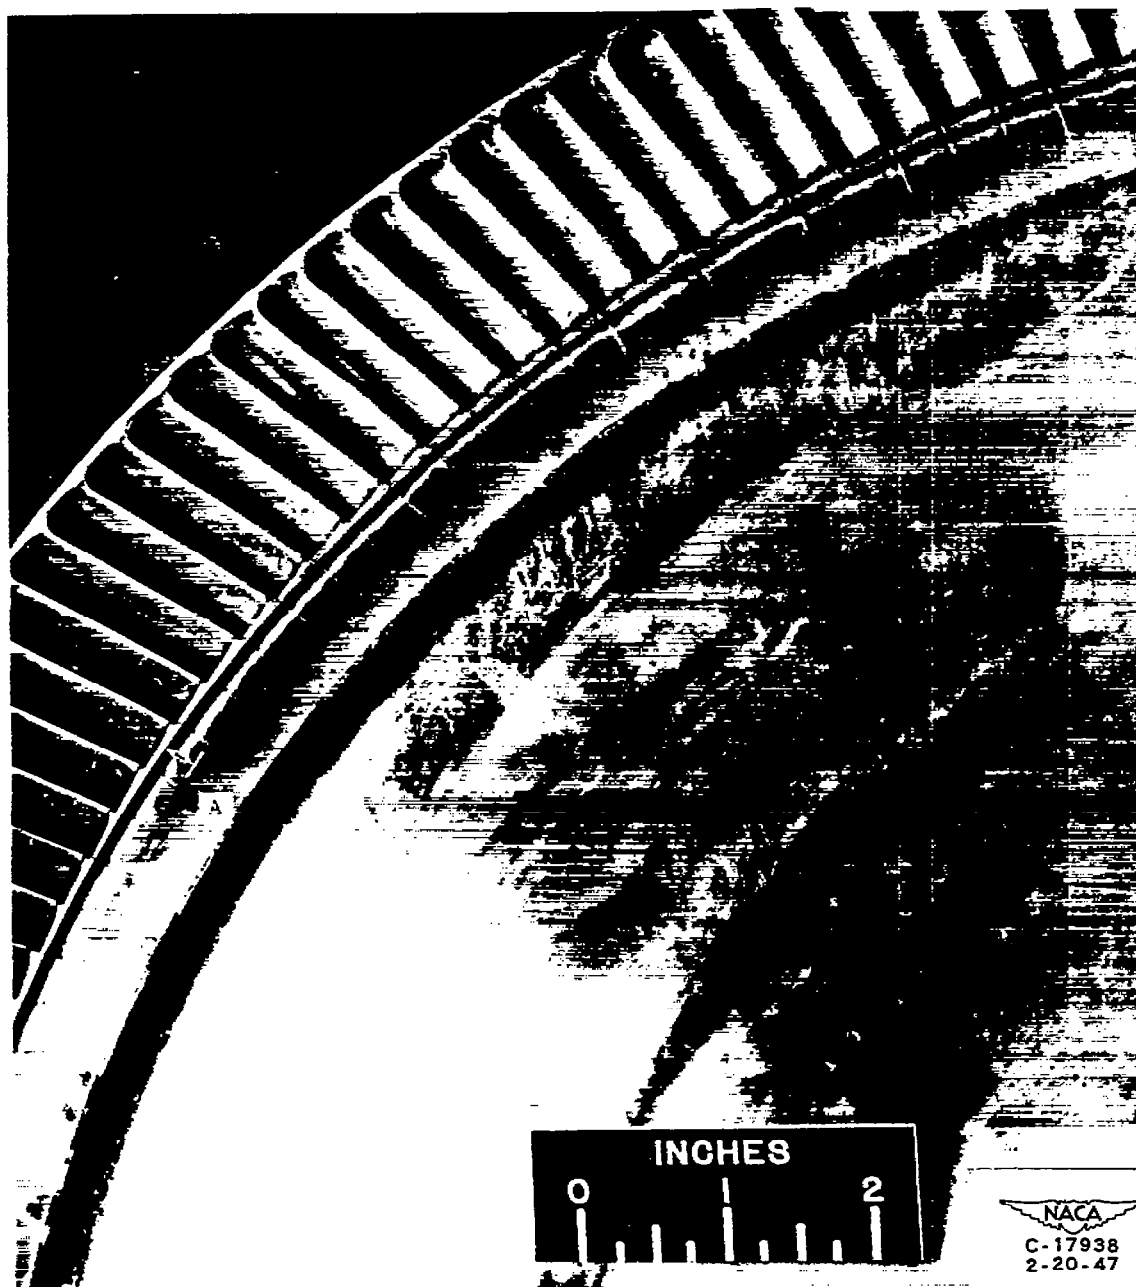
Turbine wheel and modifications. - The investigation was conducted on a composite-type gas-turbine wheel. The center was SAE 4340 steel. The $2\frac{1}{4}$ -inch radial-thickness rim, which was welded to the center part of the wheel, was Timken 16-25-6. The blades were welded to the rim. The turbine wheel was one that had been operated in a turbine-propeller engine until cracks between the blades had progressed some distance into the rim. A photograph of part of the wheel at the time it was removed from service is presented in figure 1. The length of the cracks, dimension A (fig. 1), was measured from the edge of the bevel on the rim at the base of the blades. At the time the wheel was removed from service, the average length of all cracks was 0.22 inch.

Figure 1. - Turbine wheel at time it was removed from turbine-propeller engine.

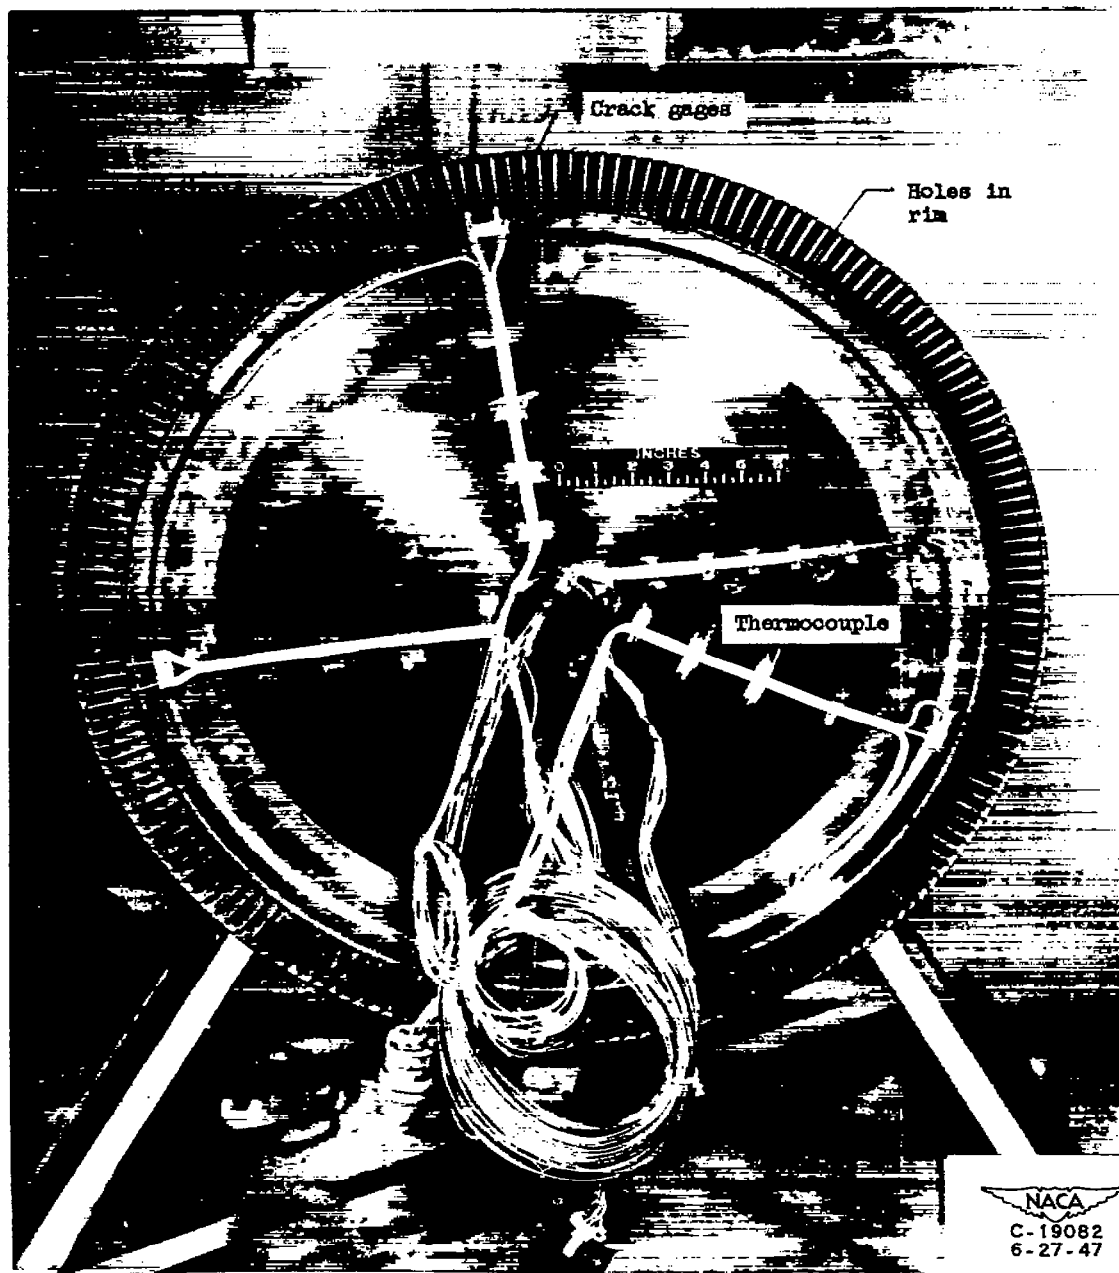
The downstream side of the wheel, after holes were drilled in groups of four, with an average spacing of 12 blades between each group of holes is shown in figure 2. Table I gives the locations and the hole sizes. The holes were drilled on the radial line between the bases of two adjacent blades, as shown in figure 3. The distance, B (fig. 3), from the center of the holes to the bevel

Figure 2. - Holes, thermocouples, and crack gages on downstream side of gas-turbine wheel.

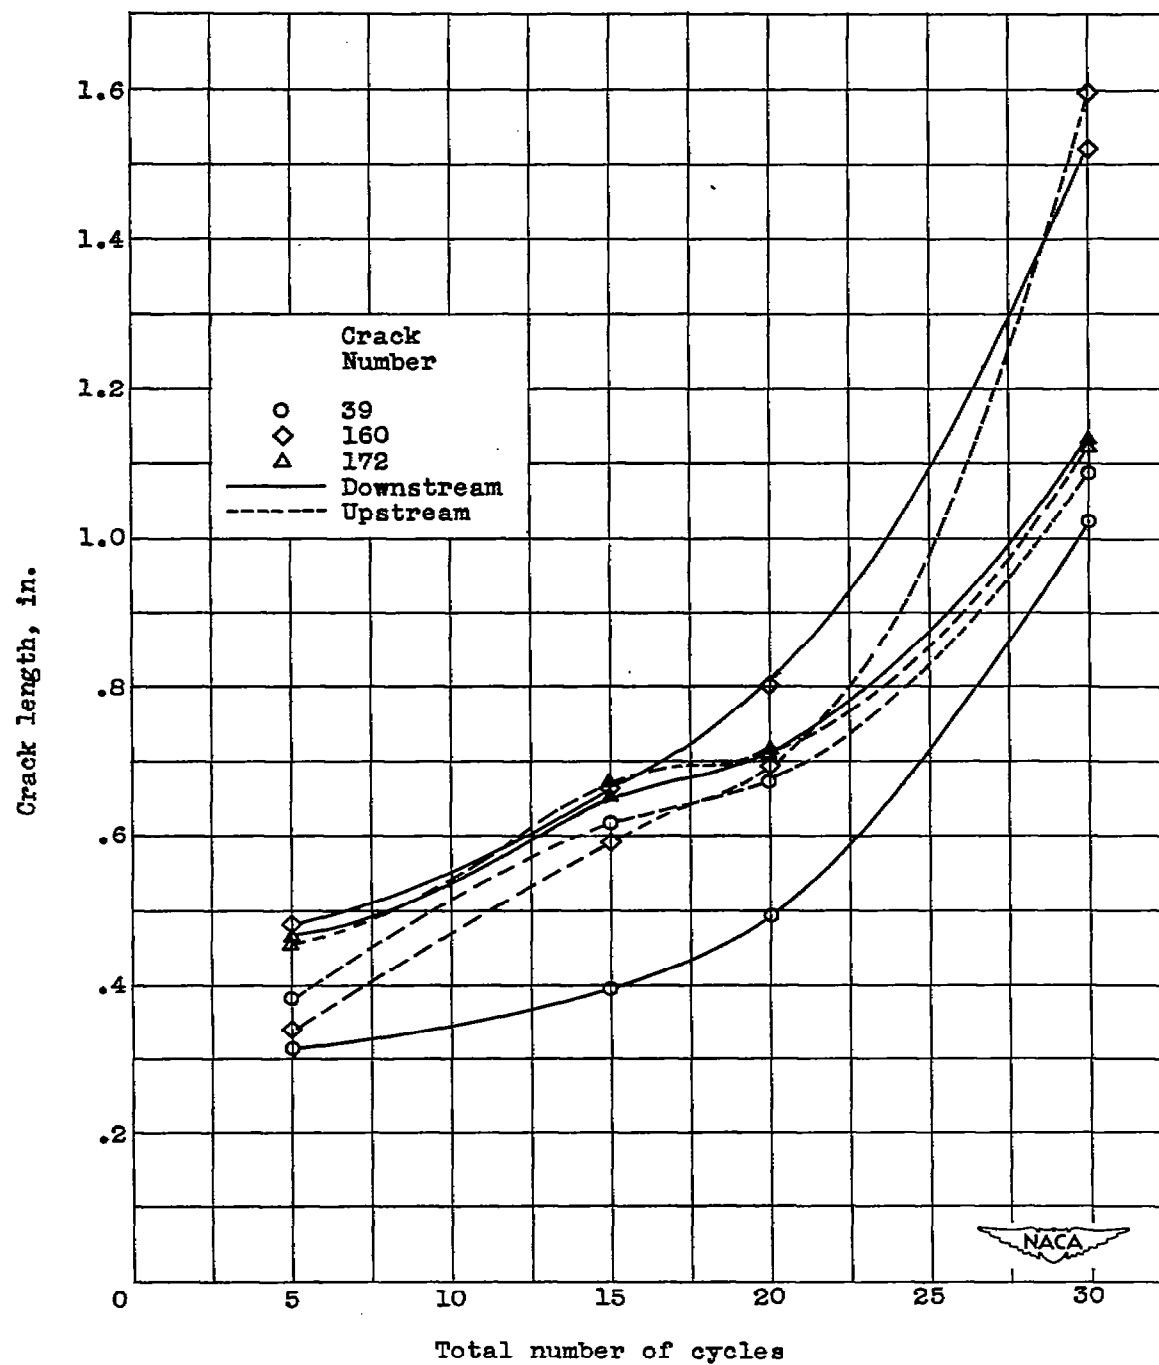
Rate of crack growth. - The results of the measurements of crack length are presented in table III. The cracks shorter than 0.22 inch seem to have grown very little or none during the runs. One reason for the apparent negative growth of the short cracks was that when the length of a crack exceeded 0.22 inch, it was not reported in this group. The omission of the longer cracks may decrease the average crack length for the remaining cracks in the group. The inaccuracies in crack measurements may also have contributed to the apparent negative growth. In general, the long cracks grew much more rapidly than the short cracks. The manner in which the long cracks grew is shown in figure 7. The rate of growth for the long cracks increased as the length of the cracks increased. This increase seemed to indicate that as the testing progressed the portion of stress relief occurring in the long cracks became larger.

Figure 7. - Growth of long cracks in gas-turbine wheel.

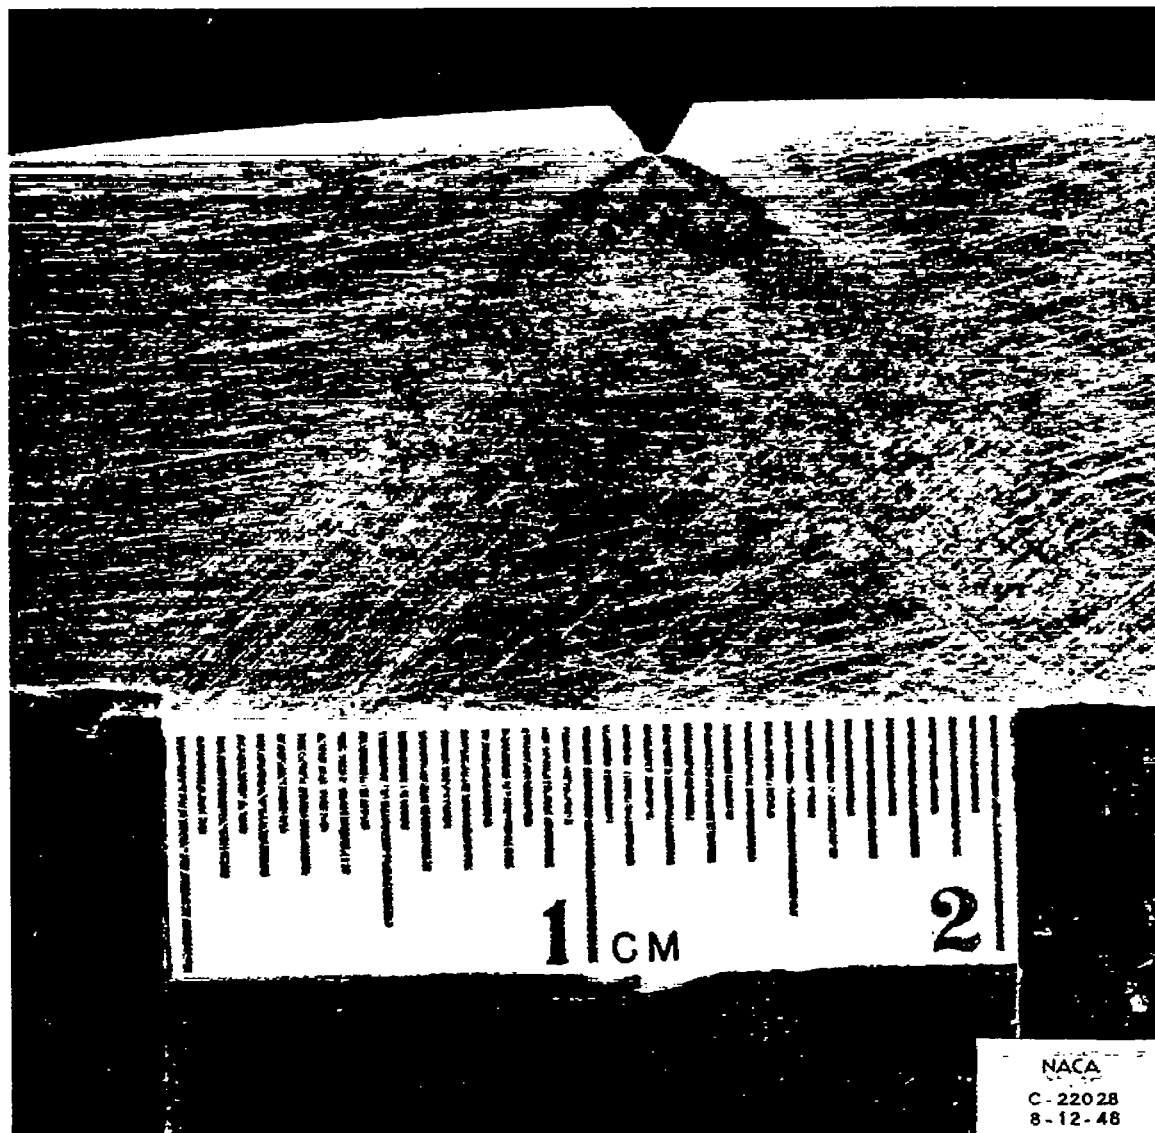
It was impossible to produce cracking at the notches in the rim under the previously described conditions. The flat disk was subjected to approximately 200 thermal-stress cycles and the tapered disk was subjected to approximately 20 cycles in which the maximum rim temperature was 1350° F. The conditions of the disks after the runs are shown in figures 12 and 13. The dark areas at the bottoms of the notches were brought out by removing the scale with a piece of emery cloth, which was supported by a flat piece of steel. These areas were depressions somewhat below the surface of the disks. The center parts were the regions of greatest depression in the dark areas. The areas at the bottoms of the notches resembled plastic-flow figures or Lüders' lines.

Figure 13. - Plastic flow at notch in SAE 1045 13.5-inch-diameter disk.

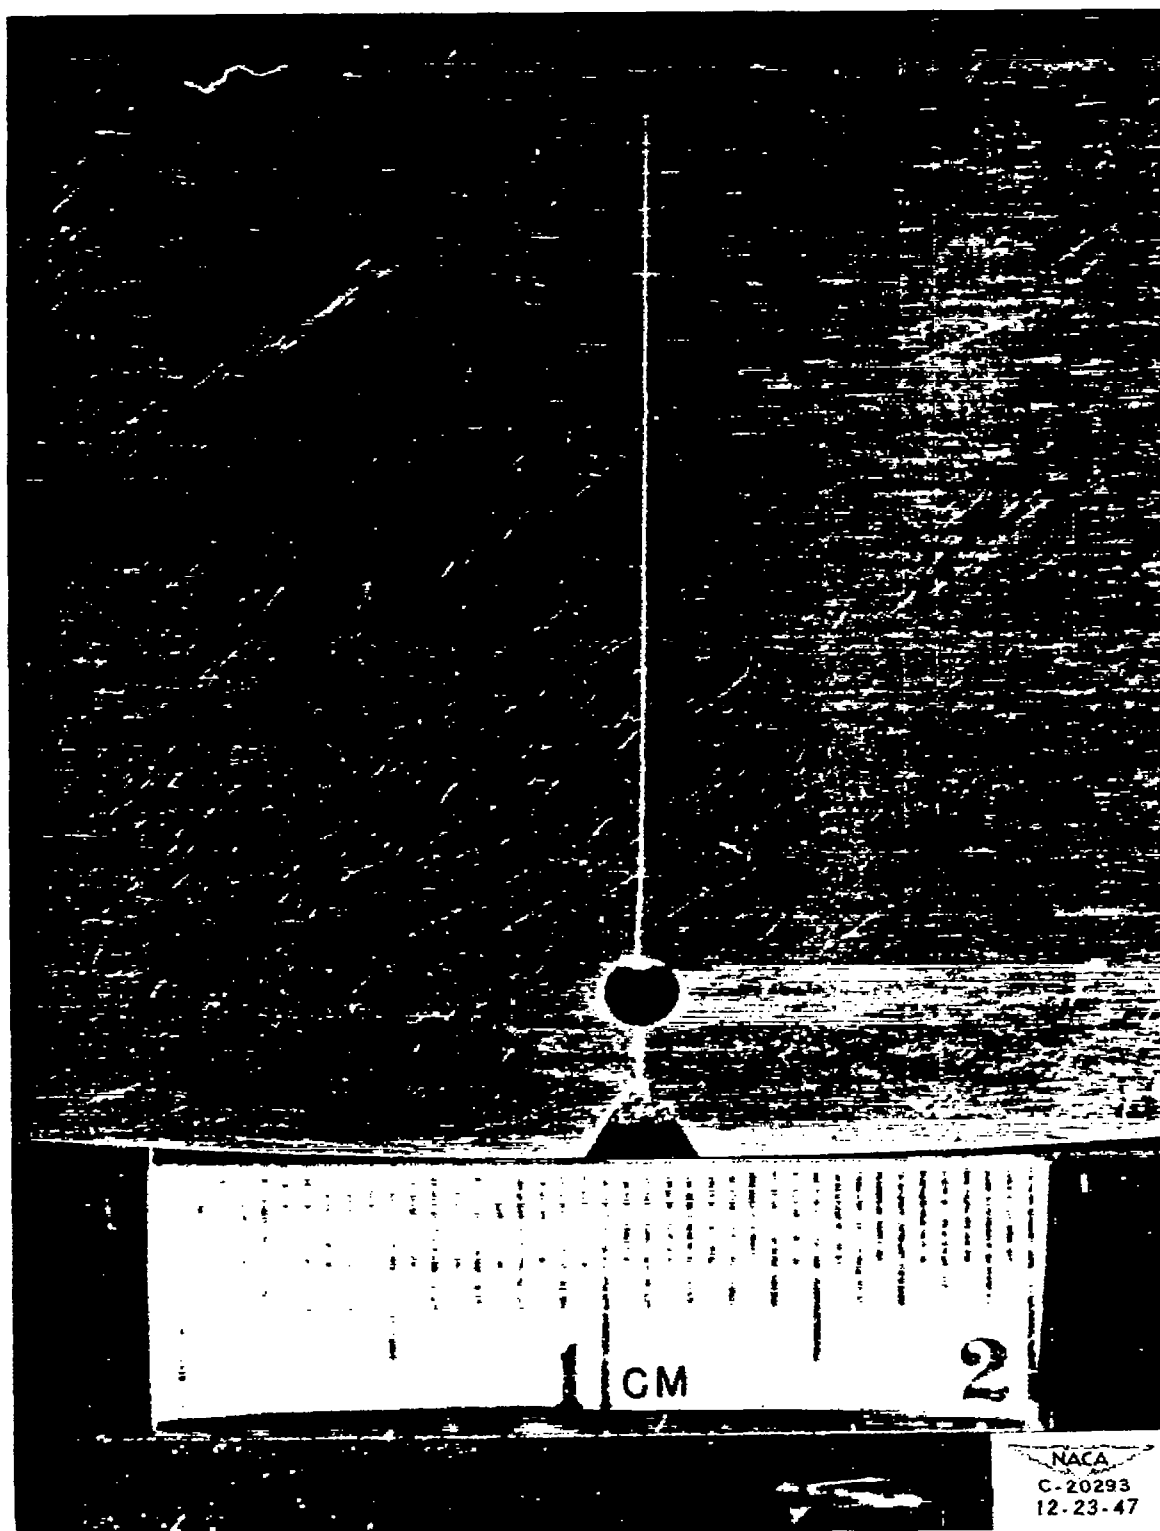
Occurrence of cracks. - With one exception, the first crack occurred between the 60°-V notch and the 1/16-inch-diameter hole. The relation between the holes and the notches is shown in figure 14. In most cases, within a few cycles after the first crack occurred and at the same temperature gradient, cracks occurred at the remaining V notches irrespective of the presence of holes. With two exceptions, no cracks occurred between the semicircular notches and the holes. In the case of the V notches without holes, the cracks generally grew about 1 inch during the cycle in which they occurred. This initial growth seemed to occur in a very short time or instantaneously. During the cycle at which the crack passed through the hole, the crack length increased about 1/4 inch. The crack lengths increased very slowly after the cycle during which they occurred. The preceding statements about rates of crack growth apply to all of the disks except the one with low hardness (Rockwell C-11). The cracks in the low-hardness disk progressed

only a very short distance during the cycle in which they occurred. The appearance of cracks in the hard disks is shown in figure 15. A typical crack in the disk with low hardness is shown in figure 16.

Figure 15. - Radial crack in 13.5-inch-diameter tool-steel disk. Hardness, Rockwell C-60.

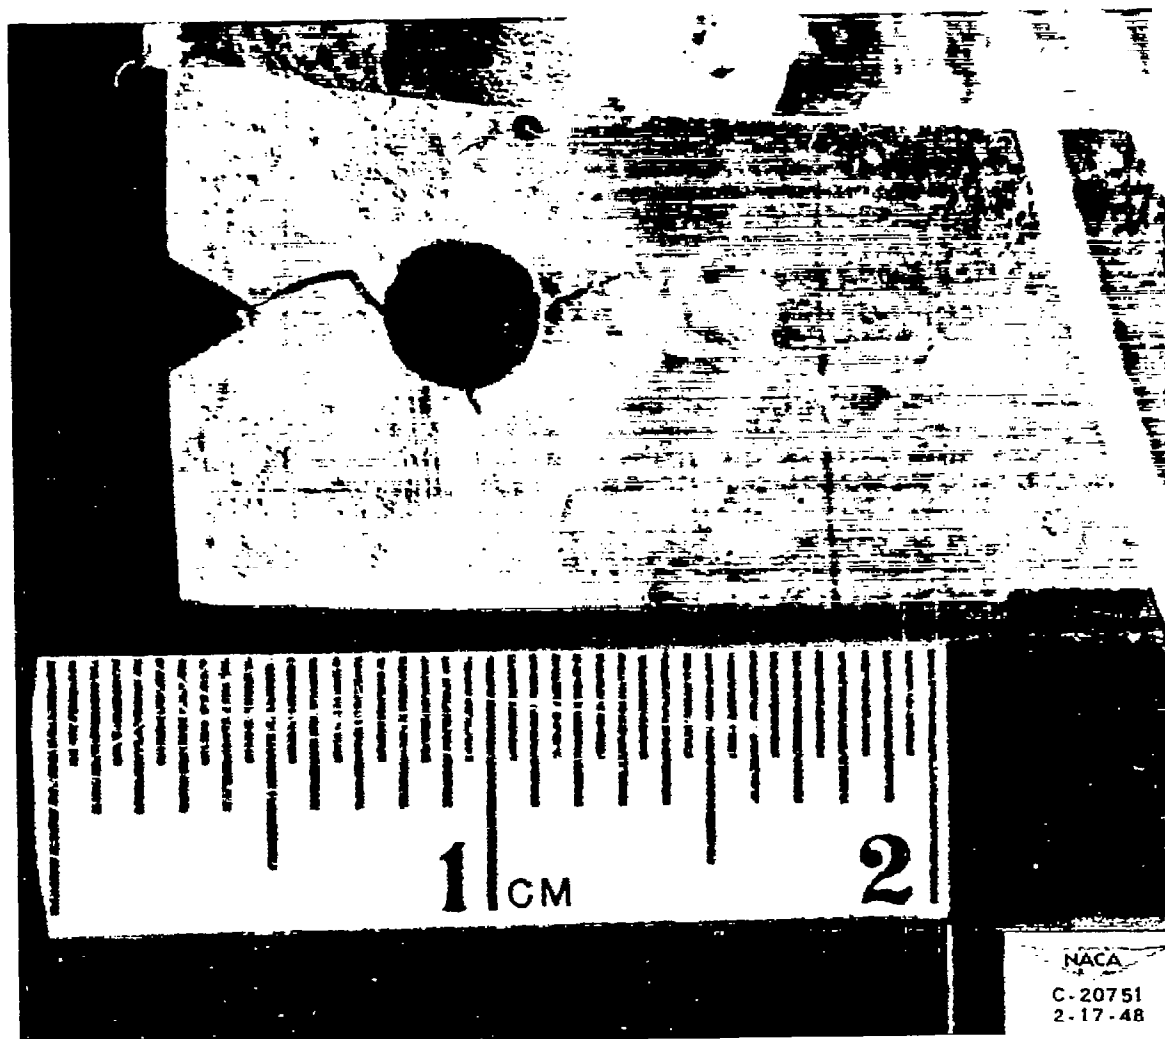
Figure 16. - Crack in 13.5-inch-diameter tool-steel disk. Hardness, Rockwell C-11.

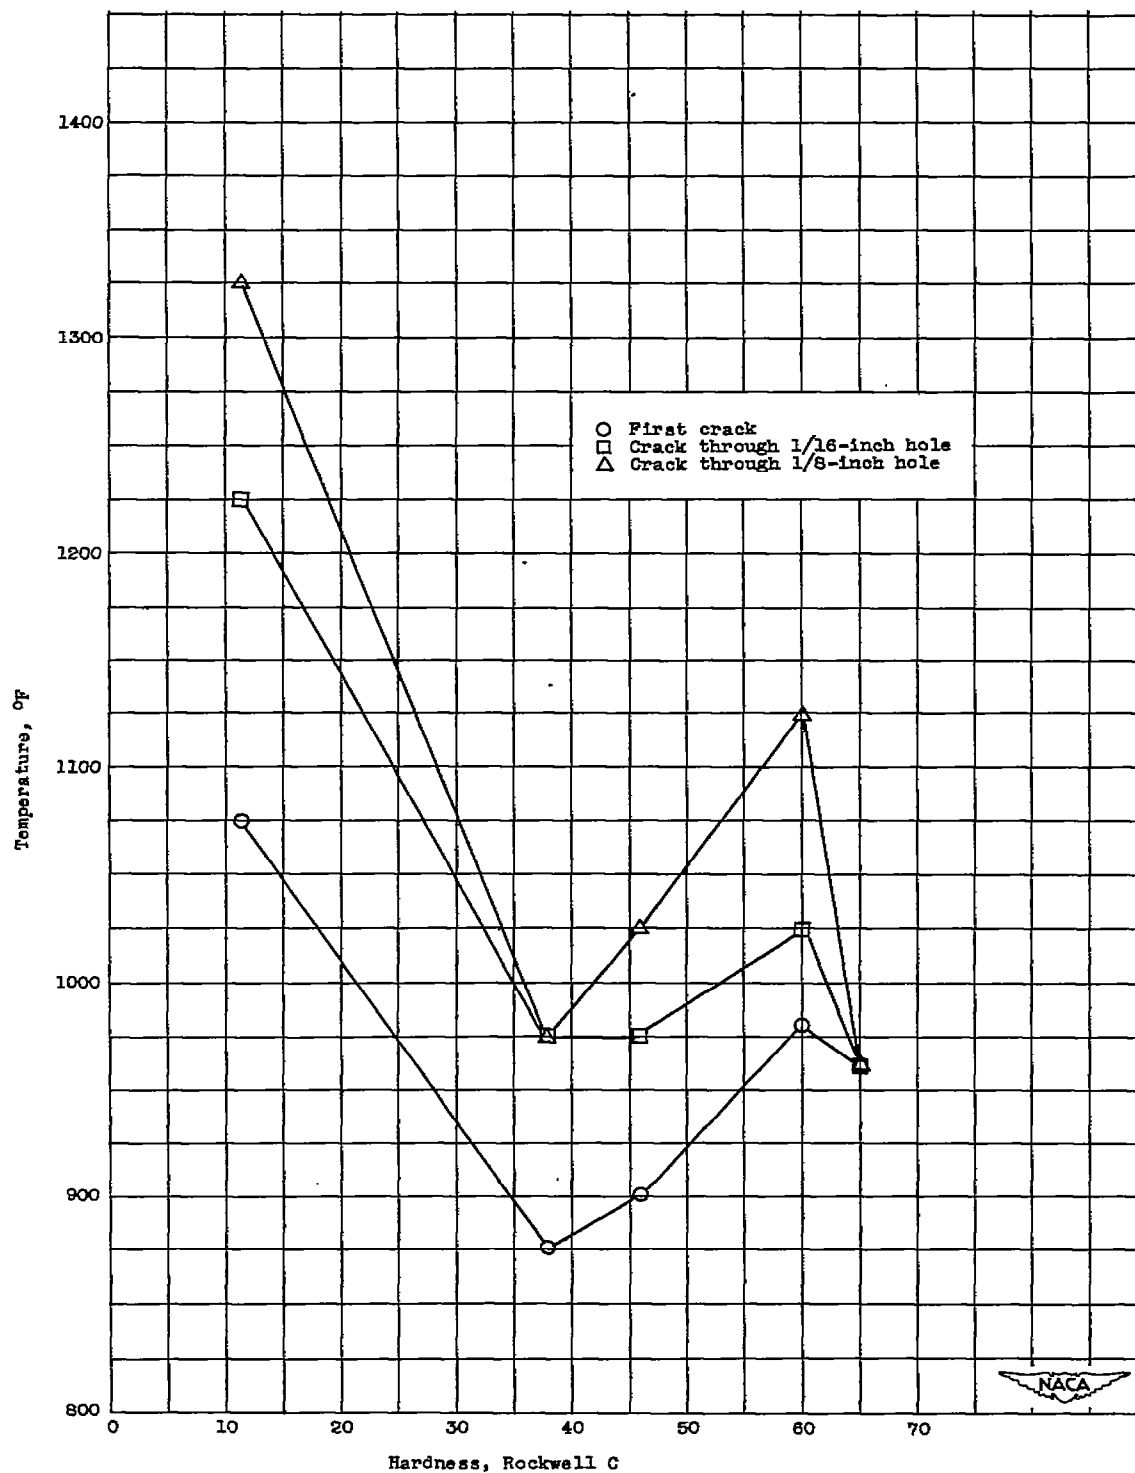
Effectiveness of holes. - The temperatures at which first cases of the several cracking phenomena occurred in the various disks are shown in figure 17. One point on each of the three curves was obtained from each disk. The hardness of the disks is indicated by the abscissa. The increase in temperature, above that producing cracks, required to cause the crack to progress through a 1/16-inch hole indicates the effectiveness of such a hole in preventing crack growth. The same statement may be made for the 1/8-inch holes, which were more effective than the 1/16-inch-diameter holes in preventing crack growth.

Influence of hardness and other factors on rim cracking. - The disks of materials with Rockwell C hardnesses of 38 and 46 had low cracking temperatures as shown in figure 17. For this range of hardness, according to references 3 and 4, tool steels of this type have low toughness and impact strength. The toughness and the impact strength are higher for disks that are harder or softer than those disks in the Rockwell C hardness range from 38 to 46. The loss of toughness or impact strength seems to have been the significant factor in causing the low cracking temperatures for disks with Rockwell C hardnesses of 38 and 46. In general, from figure 17, reducing the hardness of the disk evidently increases resistance to cracking.

Figure 17. - Cracking temperatures in 13.5-inch-diameter tool-steel disks.
